HAZARD ASSESSMENT

May 2008

Passage Island Wildfire Assessment

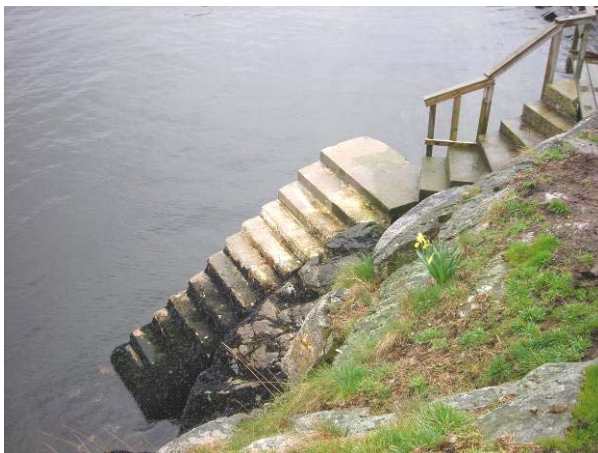
The island is only accessible by small boat at one developed landing area useable at most tidal states; this is locally known as “the North Stairs”. There is currently no “dock” at which boats could be moored directly, which would make evacuation or emergency response more challenging. It is possible to land a small craft at two other public beach areas on the South and West sides of the island; however, these beaches are not suitable as year round access points due to their rocky nature and heavy driftwood loading.

Local weather conditions often cause a strong northerly outflow wind locally known as a “Squamish” which can generate moderate waves which can prevent access to the developed landing at North Stairs, effectively isolating the island from the mainland. The two other possible landing areas are also affected by significant wave action as they area largely exposed to waves generated in the Strait of Georgia by westerly and south-easterly winds which are prevalent.

6. Residents should consider organizing an annual clean-up of common areas to reduce the ground fuel load.
7. At least one additional developed evacuation point should be identified and maintained on the island. The primary location should be the North Stairs with a secondary point at “South Beach”. In conjunction with the Ministry of Transportation, the existing wooden stairs at “South Beach” should be repaired and driftwood debris should be removed periodically to allow easy access for responders. Abandoned boats on both beaches should be removed to further ease access for emergency responders. A sign stating “Emergency Access” in large letters, clearly visible from a vessel offshore, should be placed in a prominent location at the beach.

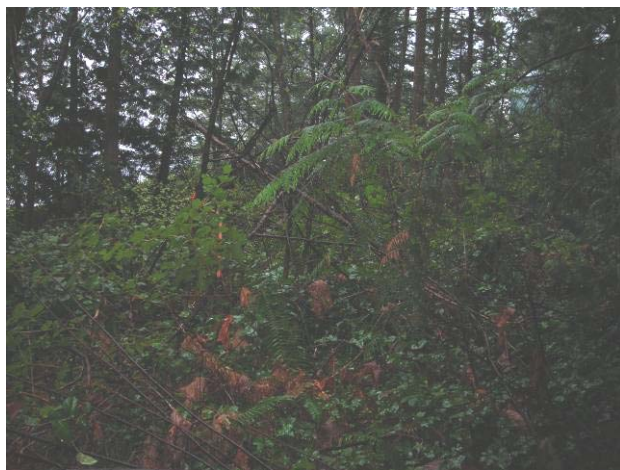
Ground Fuel Loading

The forest landscape is comprised of a mix of coniferous and deciduous trees, with conifers comprising the vast majority. Specific species identified were Douglas Fir, Red Cedar, Western Hemlock, Shore Pine, and Arbutus. Ground cover ranges from native and non-native grasses and lichens on cliff tops and open areas, to dense underbrush in central areas.

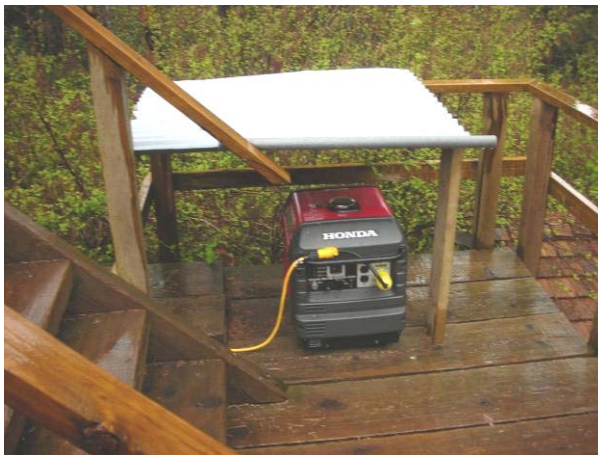
Good generator installation

The one incident of injury from fire that occurred within the last 10 years was a result of a generator fire that escalated; the resident received burns over about 40% of his body and it required significant time before rescuers could evacuate him from the island. Generators are in common use and their storage and operation could result in further fire risk due to the presence of flammable fuels and potential for sparks from exhausts.

5. Generators should be inspected and maintained in accordance with manufacturer’s instructions annually to ensure fitted spark arrestors are effective.

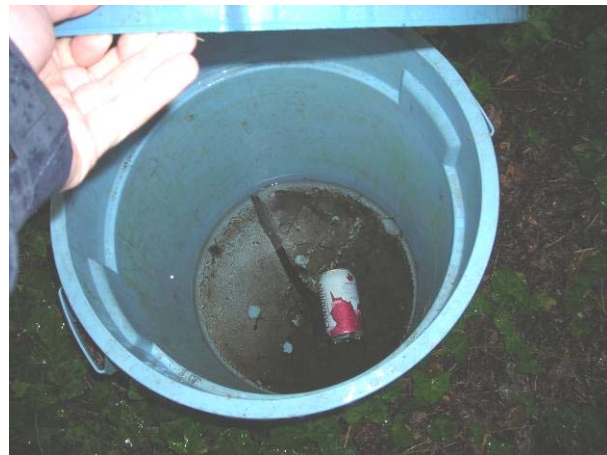
Fire bucket

Communal fire buckets were noted on the island. However, the one inspected was found to be empty. Community owned hoses are available, however these have not been maintained and may not be reliable. They are not paired with pumps for community use and thus would have to be connected to privately owned pumps which may not have compatible connections.

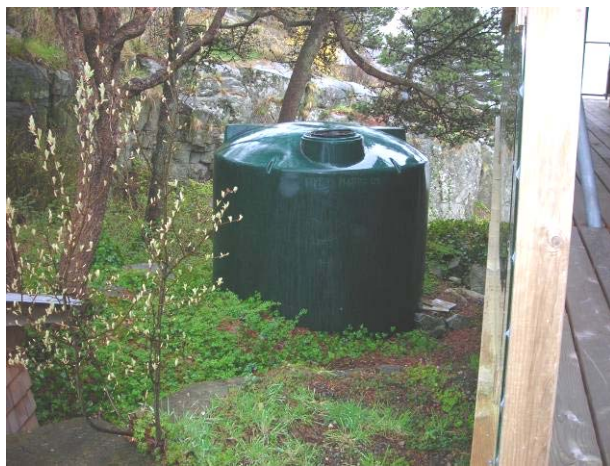
Small Cistern

No ground water availability has resulted in residences relying on rainwater cisterns ranging from 500 to several thousand gallon capacities as the only means of supplying domestic and initial fire attack water. Several residents have gasoline powered fire pumps and hoses, the general condition of which is unknown with sporadic, if any, maintenance and testing conducted.

These cisterns would likely be at a lowered level during the highest hazard period further limiting the available supply.

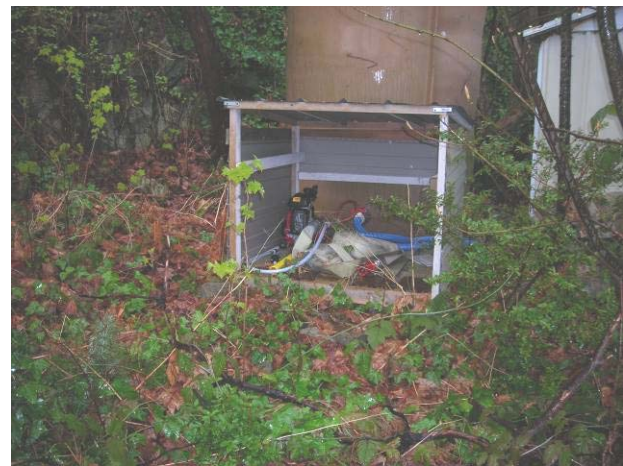
Fire Pump at a residence

The ocean waters surrounding the island are the most reliable source of fire suppression water. However, the pumps currently available on the island may not have sufficient lift capability to access this water source. Further, it is expected that adequate pressure for fire fighting could not be maintained with the current network of hoses. Use of pumps and hoses with sea water also necessitates increased maintenance immediately after use to prevent corrosion of metal fittings and degradation of hose linings.

2. Residents should consider obtaining a Mark 3 fire pump (or equivalent) for pumping seawater or drawing from cisterns without a fitted fire pump and 2000ft of 1½" hose which should be stored in a central location and be transportable by no more than two people to the majority of areas of the island. Residents should receive training in its operation and conduct annual testing of this equipment and implement a preventative maintenance program.
